AccuTech Inc.

Bathroom Ventilation Fans

Bathroom ventilation systems are designed to exhaust odors and moist air to a dwelling's exterior.

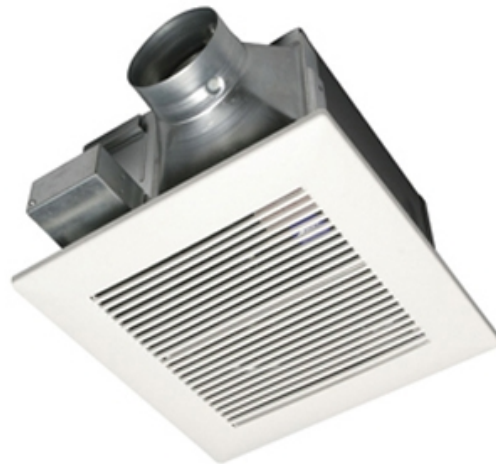
If a dwelling has an older model fan installed, it is important to make sure that it is exhausting air sufficiently for the size of the room it is in. The rate of airflow of exhaust fans is rated in CFM (Cubic Feet per Minute). There are many sources available online that can help in determining square footage / CFM requirements for bathroom exhaust fans and ducts.

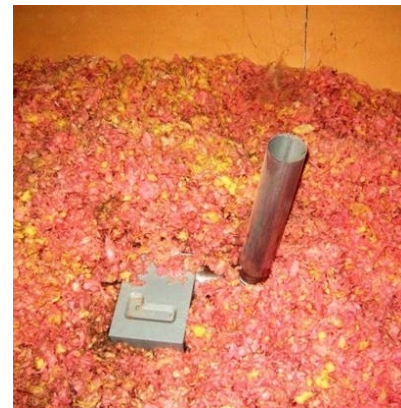
- Terminate to Exterior. Ducts should never terminate within the building envelope;
- Have a screen or louvered cover at its termination point. This is to prevent birds, rodents and insects from entering the duct;
- Be as Short and Straight as Possible. Long, curving ducts allow more time for vapor to condense in the duct and also make the exhaust fan work harder;
- Be insulated. Excessively hot or cold ducts encourage condensation.

Above all else, a bathroom ventilation fan should be connected to a duct capable of venting moist air and odors to the outdoors. Visible evidence of moisture buildup within a bathroom, attic, or crawlspace is a clear indication of improper ventilation, and should be corrected as soon as possible in order to prevent potential structural decay of building materials, as well as to prevent potential respiratory health issues to the dwelling's inhabitants.
